KOOTENAI DEVELOPMENT IMPOUNDMENT DAM

SEPTEMBER 2010 ROUTINE OWNERS INSPECTION

Prepared by: Kurt Hafferman, P.E.

Inspection Date: September 28th, 2010
Report Date: October 22nd, 2010

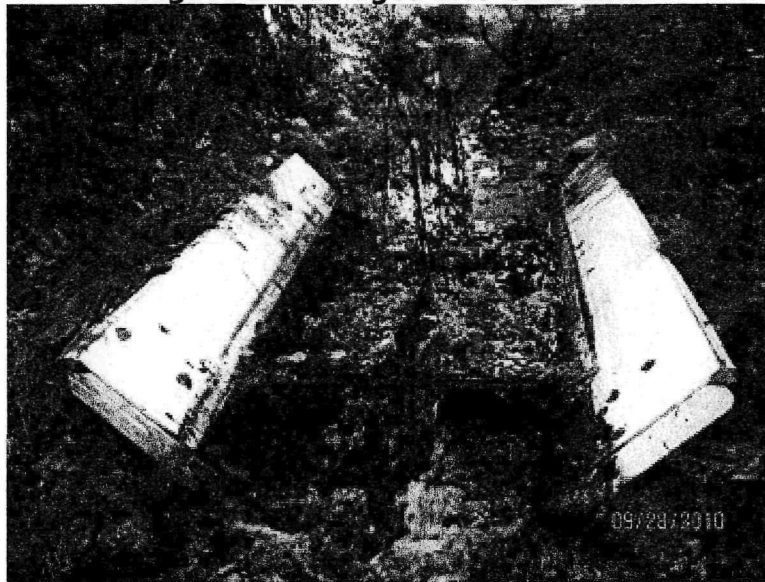
9. The LRC-01 flume was repaired from the moose damage that occurred earlier this year. Readings were taken before and after the repair. The reading before the repair was 0.55 ft. and was 0.66 ft. after the repair. The flow is expected to rise even more in the short term as the flows stabilize behind the flume. Due to the reconstruction of the flume, a new height to flow conversion chart will need to be created.

Figure 1: Damaged LRC-01 Flume

To repair the flume, a 4ft. x 4ft. sheet of ½" waterproof plywood and four, 4ft. pressure treated 2x6's were hauled onsite. An additional 8ft 2x6 was brought along just in case. Battery powered tools were brought along to facilitate repairs. The first step was to remove damaged materials from the flume and measure for the new pieces. Measurements were taken and pieces marked for cutting. It didn't take long to realize the 5 batteries would not cut all the pieces so Jeremy departed the site for additional hand tools to speed the process. I marked the remaining pieces and was able to cut the plywood before Jeremy returned. The 2x6's were then cut to support the plywood. The pieces were then assembled onto the existing flume with screws to complete the repair. See Figures 1 and 2 below for before and after photos of the Flume.

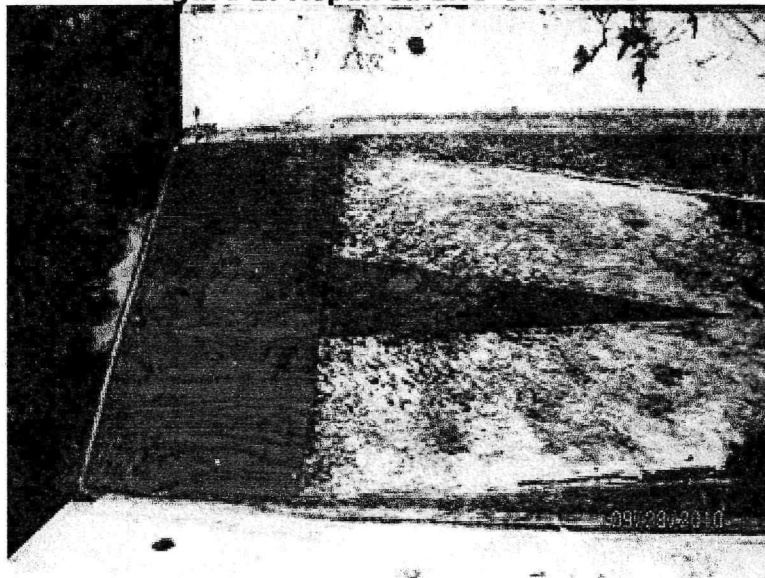
Figure 2: Repaired LRC-01 Flume

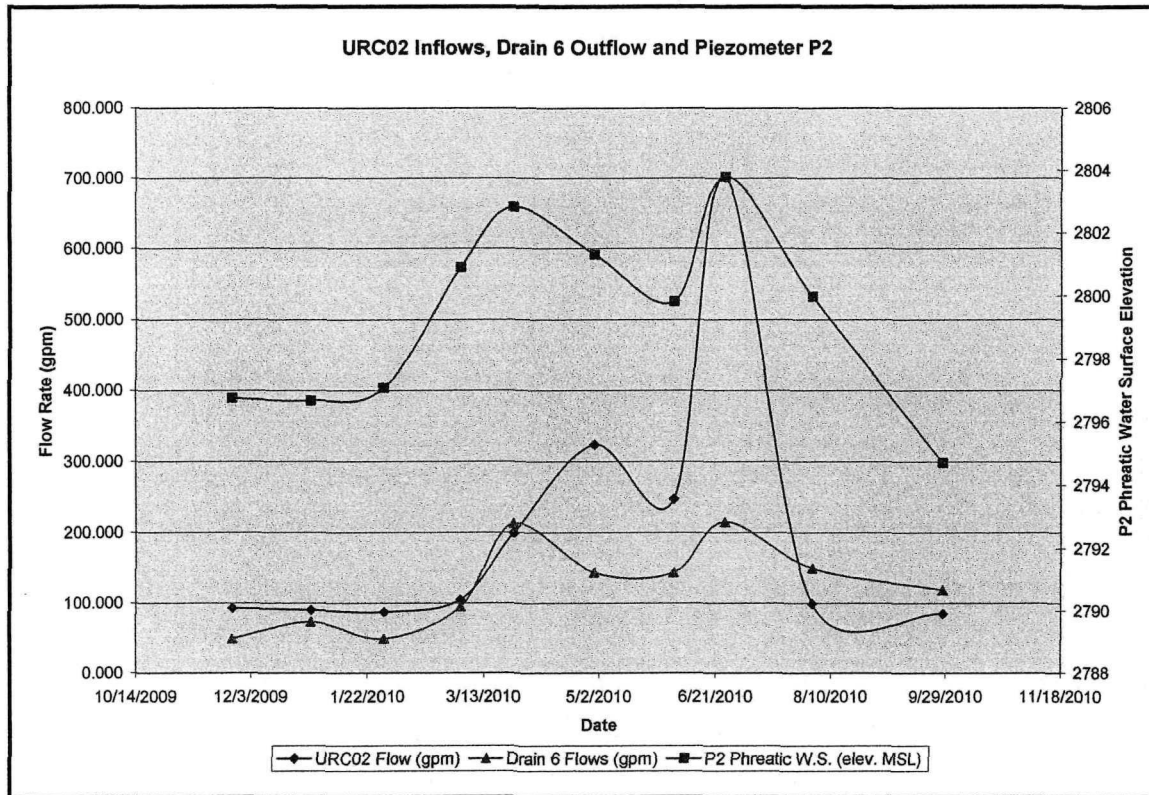
Drain 6, the main drain at the toe, increased flow from 99.2 gpm to 119.03 gpm, an increase of 19.83 gpm, or 17% since last months measurements. It is interesting to note the correlation between Rainy Creek/Fleetwood Creek inflows to the reservoir and the response in flows in drain 6. Once again we see a rise in inflows and a rise in drain 6. As expected the correlation between reservoir inflow from Rainy creek and Fleetwood creek and outflow through drain 6 has stabilized.

Figure 3: Upper Rainy Creek Inflows and Drain 6 Outflow 11/25/2009 to 9/28/2010

Although it is recognized that the frequency of water level readings, e.g., monthly, can make the points on the graph match other hydrologic events, it is clear that the shape of the curves, particularly during rapid increase and decrease in flow, and the time sequence to rises in flows, is more than coincidental. This type of evidence clearly indicates the close connection that drain 6 and the cross drain system have to the inflows.

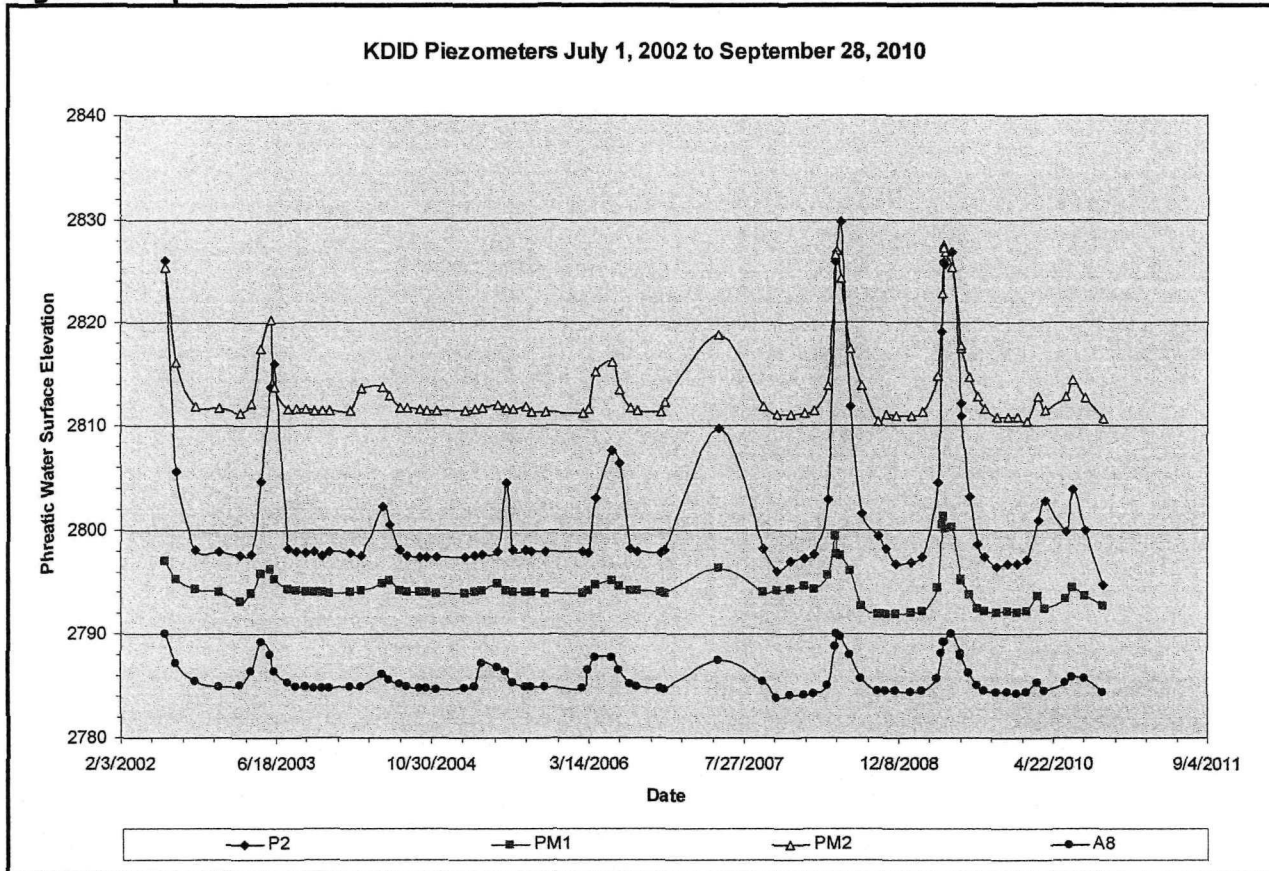
Figure 4: Updated Piezometer Plots

The graph above shows the rise that occurred in late April which was followed by a decline in May and then another rise in late June and then the fall beginning in July. This graph shows that highest phreatic water surface in the piezometers only rose to the levels such as those seen in 2003 or 2004.

It is interesting to note the current level of Piezometer P2. The water level encountered on this inspection is slightly lower than the previously considered bottom of hole. Previous inspection data is being compiled on Piezometer bottoms to determine any impacts on the dam not previously seen. Further data may be compiled during next months inspection.

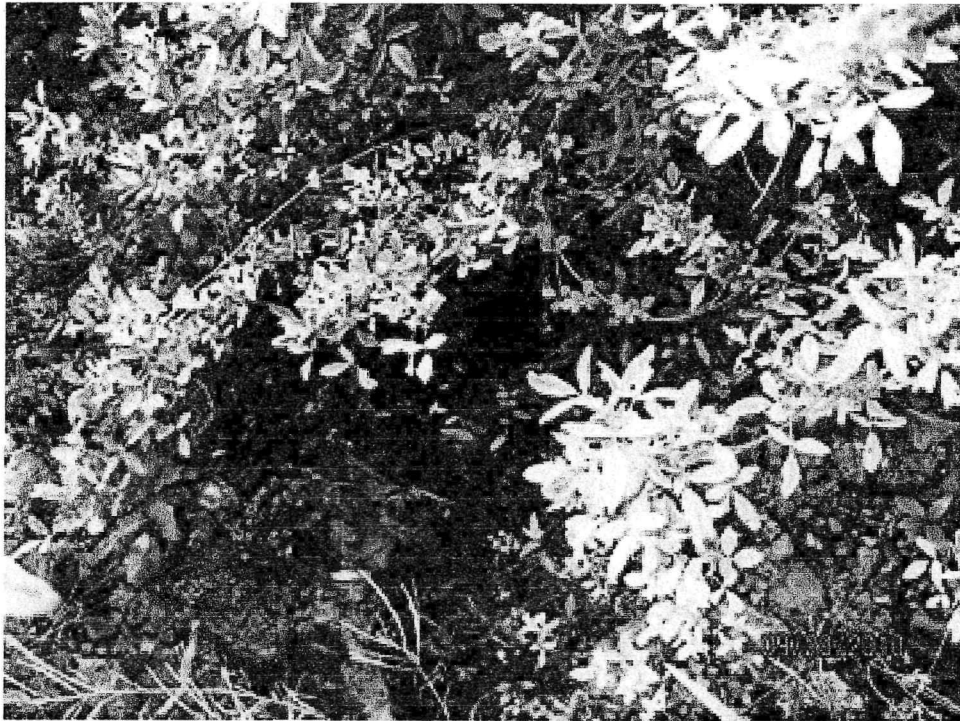
6. Drains were inspected and the flow in the drains and stream channel below the drains were recorded. Flows in Drain 6, and the flume for Drains 7/8 increased slightly. Seepage was noted below drain 7, but was less than last month. All drain flows were clear and steady.

Toe Drain 7 Close up

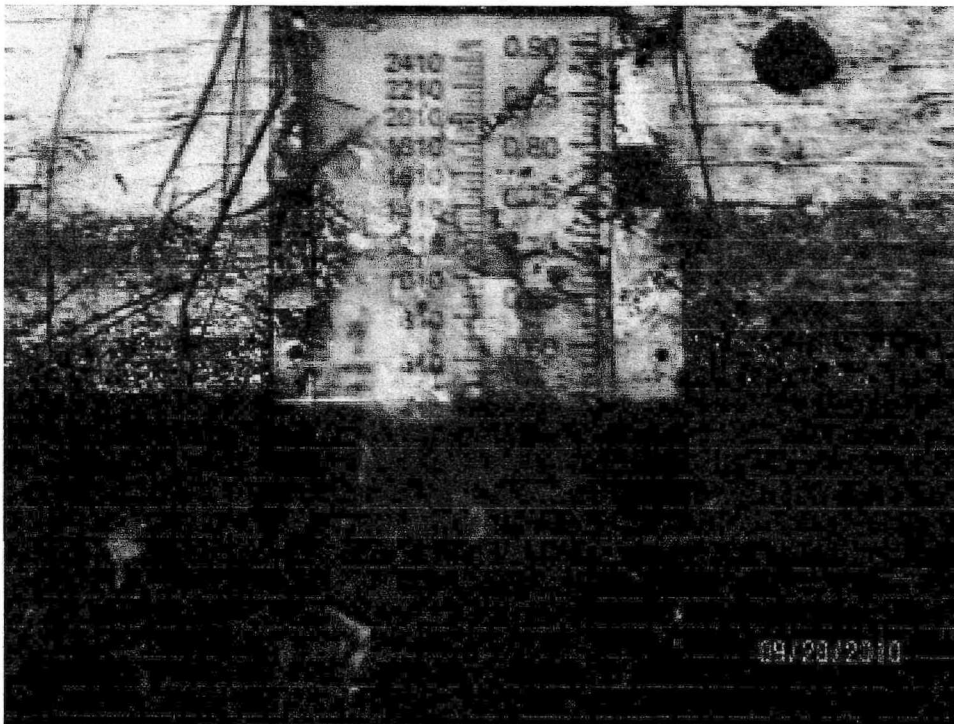
LRC-01 Before Repair

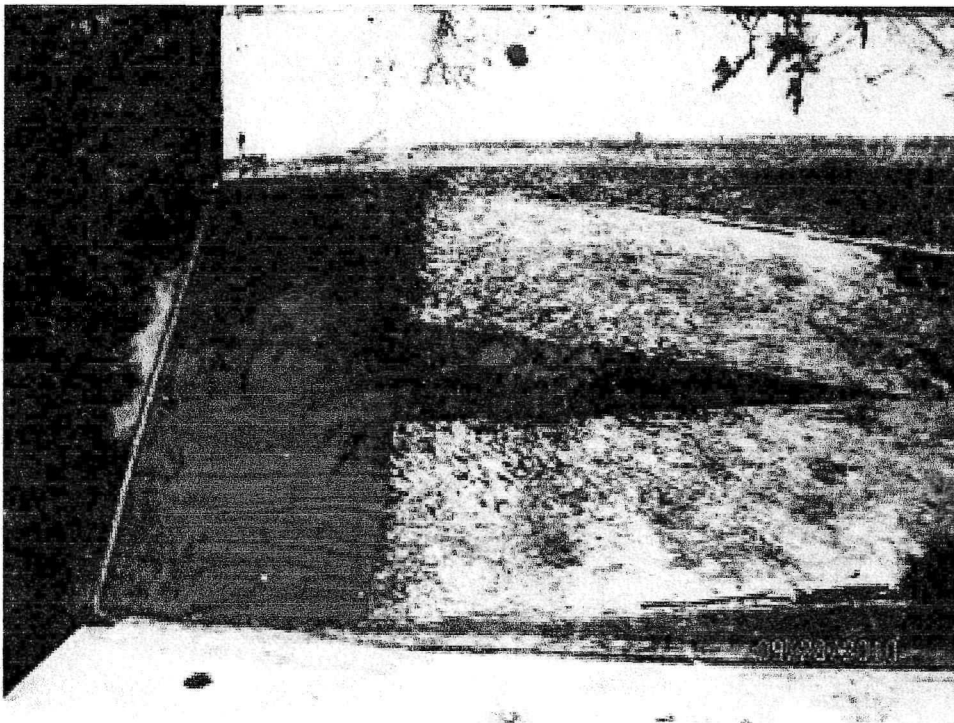
Repaired LRC-01 Looking Upstream

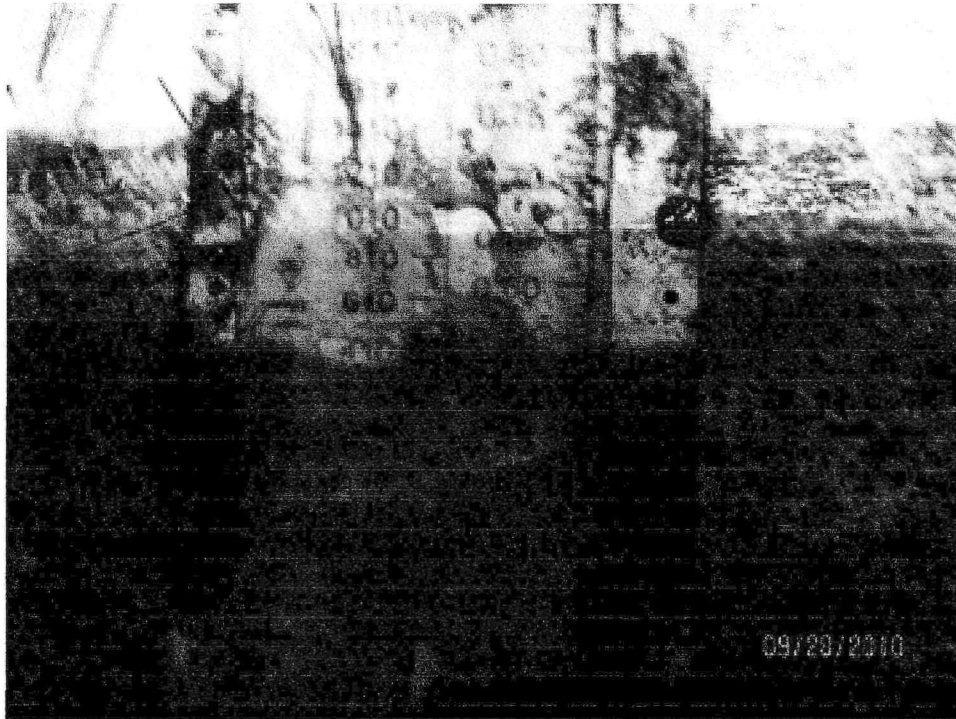
LRC-01 Completed Repair
